A Review of The Final Turbine Inspection Report at the Lahendong Geothermal Power Plant

Reza Muhamad* & Raden Dadan Ramdan

Institut Teknologi Bandung
*Email: 22623057@mahasiswa.itb.ac.id

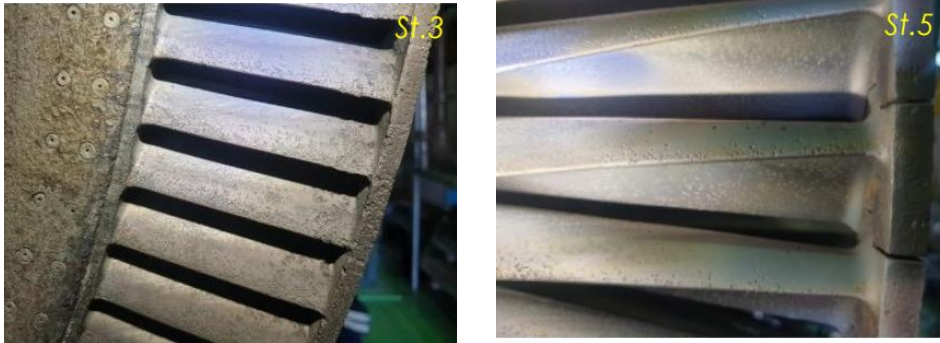
Figure 2 Pitting on the surface of turbine blades [4]

Pitting was predominantly found on the leading edge of the blades. The primary causes of this damage are steam impurities and surface deposits, with chlorides (Cl) and sulfates (S) identified as the main corrosive elements. These substances can easily diffuse up to 3–4 mm into the blade material. Additionally, the accumulation of dissolved oxygen within liquid films and wet deposits can promote pitting formation, especially during unit shutdown periods.

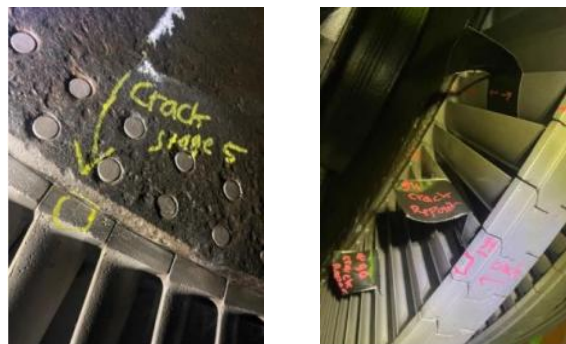
Figure 3 Crack presence on the shroud and root of the stage-5 turbine blade [4]

Crack formation was observed in stage-5, specifically in the shroud and root areas of the turbine blade. Visual inspection revealed that the cracks appeared linear and aligned with the axial direction of the rotor blade. The average crack length

measured approximately 7 mm on the shroud and around 10 mm on the blade root. This condition is particularly concerning since the root area is subjected to the highest stress concentration within the blade structure. Moreover, the widespread presence of pitting corrosion on the rotor blade components could have acted as a trigger for initial crack development.

The cracks found in the shroud and root of the stage-5 blade exhibit a straight pattern, following the axial orientation of the blade, which is indicative of a fatigue failure mechanism. Fatigue can be influenced by both environmental and mechanical factors. In this case, the environmental influence stems from severe pitting corrosion, while the mechanical aspect is related to cyclic loading experienced by the rotor blade. Based on the evidence, it is highly likely that both factors contributed to the development of cracks in this component.

Referring to API 687 section 3.4.2, blades can generally be repaired if the crack is caused by a foreign object. If the crack is caused by factors other than a foreign object, further analysis is required. Therefore, an in-situ metallographic test was conducted.

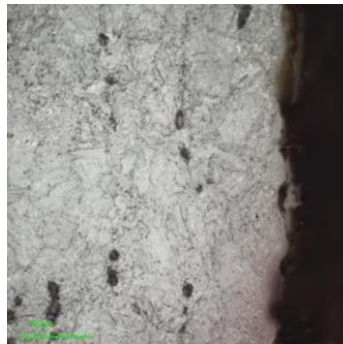
Figure 5 The crack location on the stage-5 turbine blade magnified at 1000x [4]

Indications of cavities were found along the grain boundaries, progressing into the stage of directionally oriented cavities leading to microcrack formation. Visually, macrocracks were also observed. According to Neubauer's standard, this condition corresponds to Grade 5, for which blade replacement is recommended based on VGB Guidelines. Initially, based on the results of visual inspection and with reference to API 687, the turbine blade was considered for repair; however, further analysis indicated that blade replacement is required.

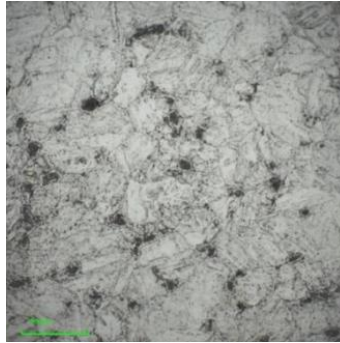
Figure 6 Magnification of 1000x on the stage 5 turbine blade, that far from the crack area [4]

Indications of cavities were also identified along the grain boundaries, entering the stage of directional cavity formation toward microcracks. Based on Neubauer's classification, this condition falls under Grade 4, and it is recommended to perform a reinspection after 10.000 hours of operation.
